- **NO START—WILL NOT CRANK—BATTERY DISCHARGED—VEHICLES BUILT BEFORE 7/18/90**
- **BATTERY—DISCHARGED—VEHICLES BUILT BEFORE 7/18/90**
- **LAMP—LUGGAGE COMPARTMENT—WILL NOT SHUT OFF—VEHICLES BUILT BEFORE 7/18/90**
- **WIRING—LUGGAGE COMPARTMENT LAMP—GROUNDED—VEHICLES BUILT BEFORE 7/18/90**

**Article No.
90-19-11**

MERCURY: 1991 CAPRI

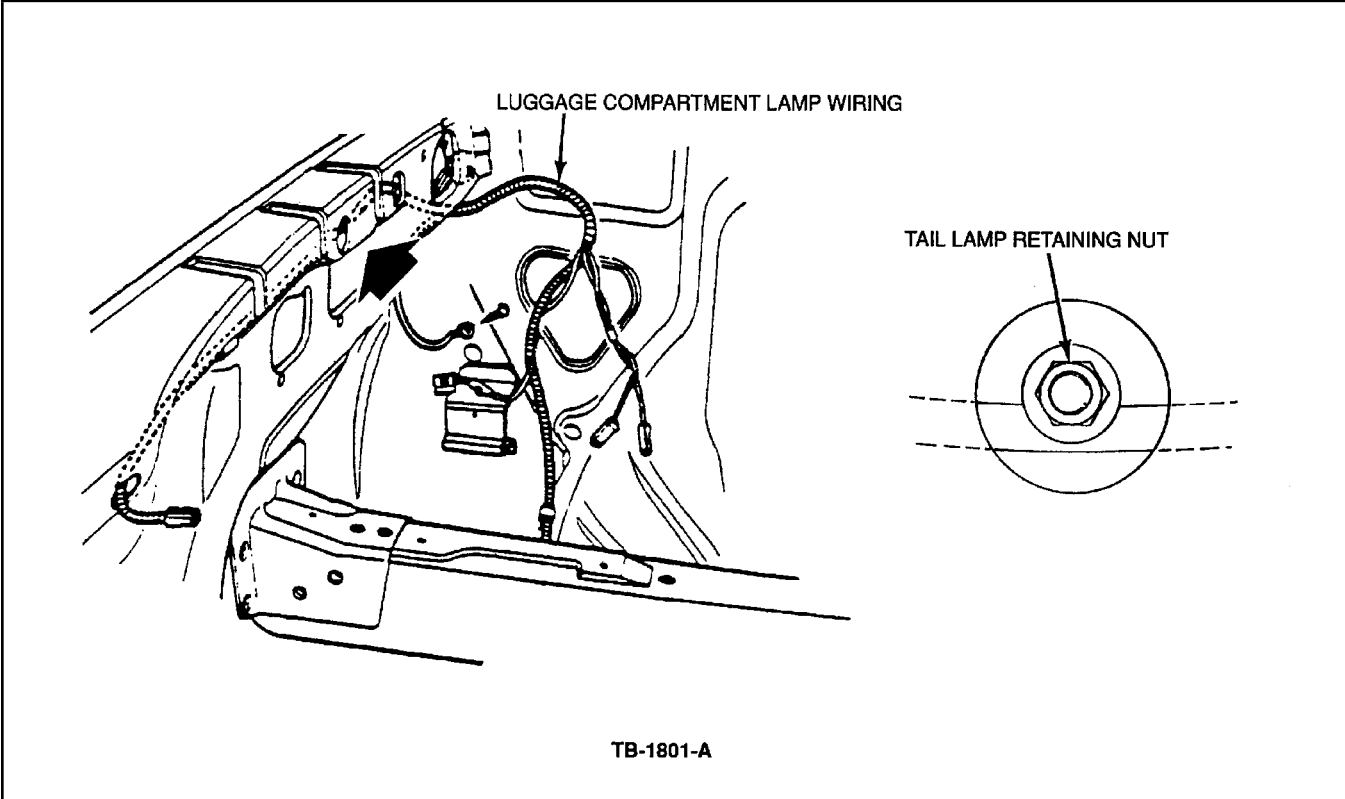
Figure 1 - Article 90-19-11

The luggage compartment courtesy lamp may not shut off when the decklid is closed. This occurs because the lamp switch wire is grounded, trapped or damaged, between the left hand side tail lamp retaining nut and the body panel. This condition also causes the battery to eventually discharge resulting in a no start condition.

1. Raise the deck lid.
2. Remove the upper back trim panel. Refer to the 1991 Capri Shop Manual, Section 45-03, for service details.
3. Using a shop light, inspect the courtesy lamp switch wiring to see where it is trapped, Figure 1.
4. Loosen the tail lamp retaining nut and free the trapped wiring.
5. Re-tighten the retaining nut.
6. Remove the deck lid latch retaining screws and remove the latch from the body panel.
7. Disconnect the courtesy lamp switch wire from the latch.
8. Reposition the courtesy lamp switch lamp wire.
 - a. Tie a piece of string 36" (900mm long) to the wire connector.
 - b. Pull the wire toward the left side of the body enough to clear the upper back panel.
 - c. Leave the string in the upper back panel to assist in reassembly.

9. Inspect the damaged section of the wire.
 - If only the wiring insulation is damaged, apply electrical insulation tape to make the repair. Proceed to Step #11.

- If any strands of the wire are broken, proceed to Step #10.
10. Repair the damaged wire as follows:
 - a. Remove the damaged portion of the wire.
 - b. Splice the wire using solder and a "duraseal" butt splice connector. Refer to TSB 86-3-11 for service details.
