<ul style="list-style-type: none"> • CONVERTIBLE TOP—“RATTLES” AND “SQUEAKS” FROM B-PILLAR • NOISE—“RATTLES” AND “SQUEAKS” FROM B-PILLAR 	Article No. 90-24-5
--	--------------------------------

MERCURY: 1991 CAPRI

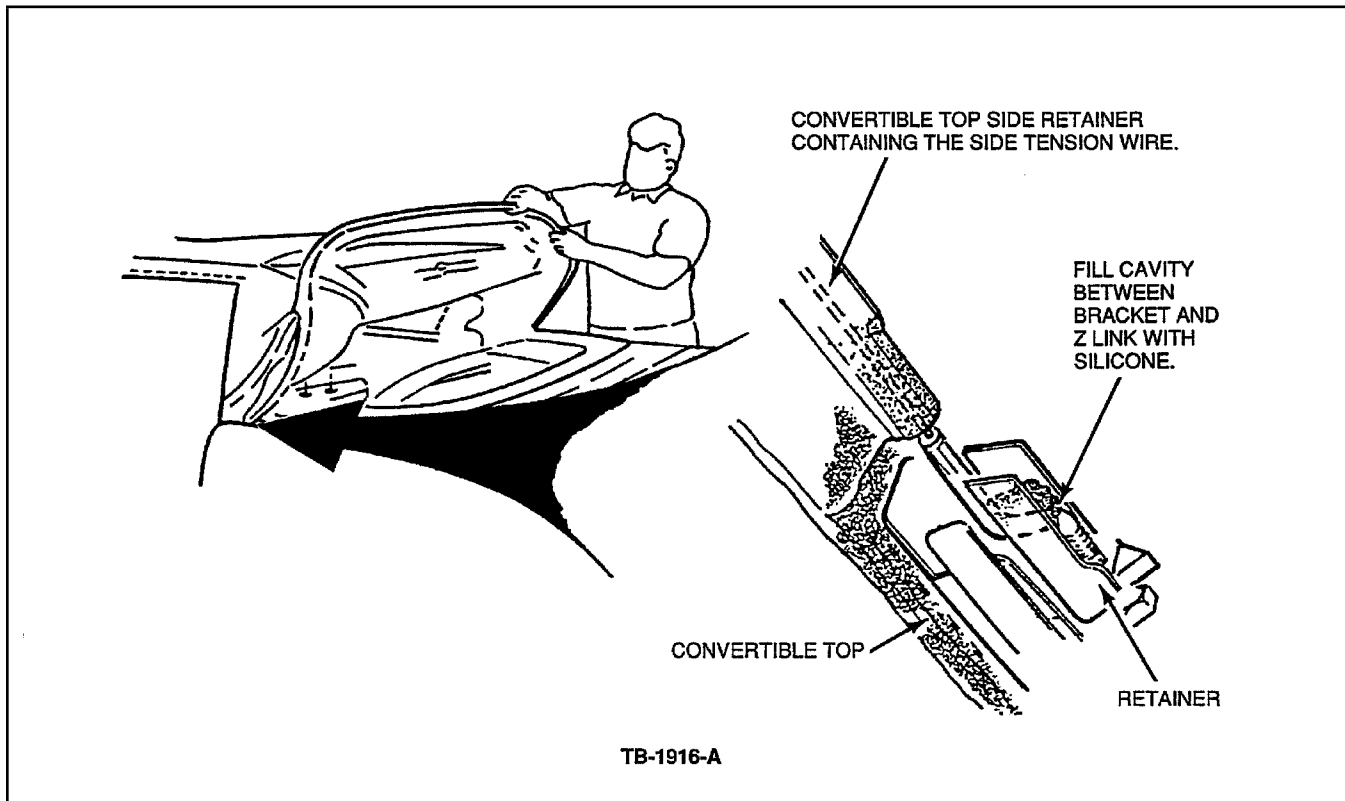
Figure 1 - Article 90-24-5

“Rattles” and “squeaks” may come from the “B” pillar at the convertible top side tension wire attaching points. This is caused by movement of the 'Z' link inside the pivot retainer.

Apply silicone rubber over the side tension wire 'Z' link to stop it from moving inside the pivot retainer. Refer to the following procedure for service details.

1. Unhook the convertible top from the rear retainer and fold the rear section forward, Figure 1.
2. Fold back the convertible top side fabric to access the side tension wire 'Z' link and pivot retainer.
3. Apply black silicone rubber over the 'Z' link, Figure 1. Repeat this operation for the opposite side of the convertible top.

4. Attach the convertible top to the rear retainer.
5. Latch the convertible top, allowing the silicone rubber to cure with the side tension wires tight.
