MERCURY: 1991-1993 CAPRI**ISSUE**

This TSB article is designed to assist the technician in diagnosing and repairing water leaks that may appear at the top corners of the convertible top.

Article No. 96-10-2 Cont'd.

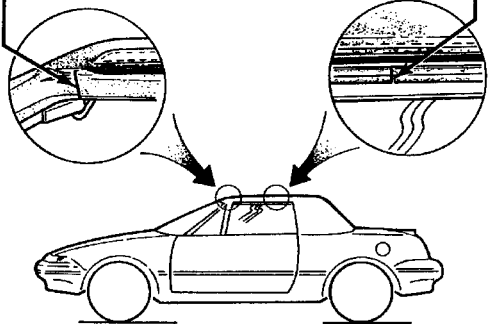
Figure 2 - Article 96-10-2

ENSURE WEATHERSTRIPS MEET AND THAT JOIN IS FLAT AND FLUSH

WEATHERSTRIPS TO SEAL WITH END-TO-END CONTACT

BE SURE MATING SURFACES ON THE FRONT SIDE RAIL WEATHERSTRIPS JOIN FLAT AND MEET FLUSH WITH THE WINDSHIELD HEADER WEATHERSTRIP. IF DIFFICULTY IS EXPERIENCED IN SEALING THE MATING SURFACES, APPLY FOAM TAPE (E9JY-7651410-A) TO THE JOINT. REFER TO FIGURE 2.
